**Flood Control Project Maintenance
Levee Inspections**

Maintenance Issue Types Only, Levee Inspection Report By Mile - Fall 2016

Sutter Maintenance Yard Maintenance Area 0001

Waterway	Bank	Unit Miles	Inspection Start/End	Inspector
Unit No. 01 Sacramento River	Right	16.76	11/01/2016 11/01/2016	Tariq Chechi

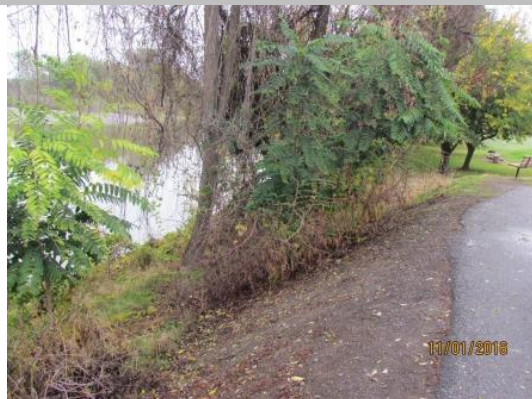
Photo 1 of 1 : FA_2016_MA0001_297_102_20161104_00158.jpg

LM Start	0.67	Rating **	M	Issue No.	102
LM End	0.69	Issue Type +	Ma	Location *	WS
Category	Earthen Levee			GPS Latitude/Longitude	
				Start	End
Item	Trim / Thin Trees			39.216513 °	39.216642 °
				-122.012440 °	-122.012773 °
DWR ID	DWR_MA0001_01_f_2016_102				
Comment Code					
T1 : Trim trees to at least five feet above ground level.					
Inspector Comment

View of a tree obstructing visibility and access.

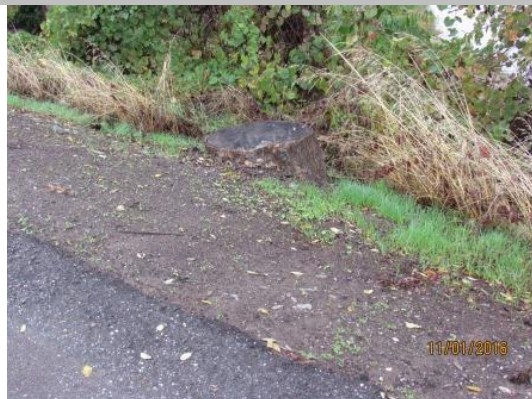
Photo 1 of 1 : FA_2016_MA0001_297_103_20161104_00159.jpg

LM Start	0.68	Rating **	N	Issue No.	103
LM End	0.68	Issue Type +	Ma	Location *	WS
Category	Earthen Levee			GPS Latitude/Longitude	
				Start	End
Item	Trim / Thin Trees			39.216560°	39.216560°
				-122.012530°	-122.012530°
DWR ID	DWR_MA0001_01_f_2016_103				
Comment Code					
T5 : Tree stumps.					
Inspector Comment

View of a tree stump along the waterside slope.

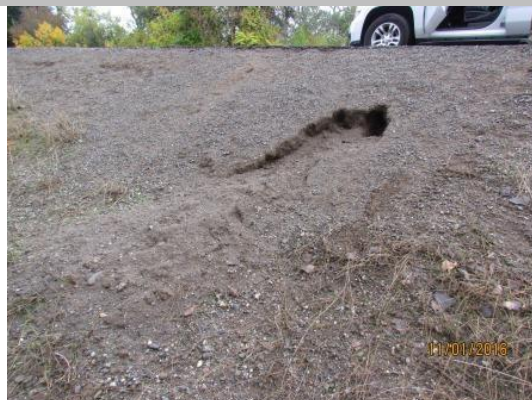
Photo 1 of 1 : FA_2016_MA0001_297_104_20161104_00161.jpg

LM Start	1.11	Rating **	M	Issue No.	104
LM End	1.11	Issue Type +	Ma	Location *	LS
Category	Earthen Levee			GPS Latitude/Longitude	
				Start	End
Item	Slope Stability			39.220728 °	39.220728 °
				-122.015885 °	-122.015885 °
DWR ID	DWR_MA0001_01_f_2016_104				
Comment Code					
S1 : Repair slope instability.					
Inspector Comment

View of a slope instability issue along the landside slope.

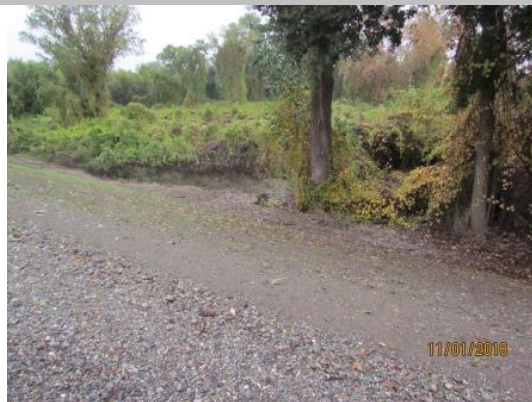
Photo 1 of 2 : FA_2016_MA0001_297_105_20161104_00162.jpg

LM Start	2.16	Rating **	M	Issue No.	105
LM End	2.16	Issue Type +	Ma	Location *	WS
Category	Earthen Levee			GPS Latitude/Longitude	
				Start	End
Item	Erosion / Bank Caving			39.235107 °	39.235107 °
				-122.013567 °	-122.013567 °
DWR ID	DWR_MA0001_01_f_2016_105				
Comment Code					
E2 : Schedule repair of erosion site prior to the next inspection.					
Inspector Comment

View of an erosion site along the waterside berm.

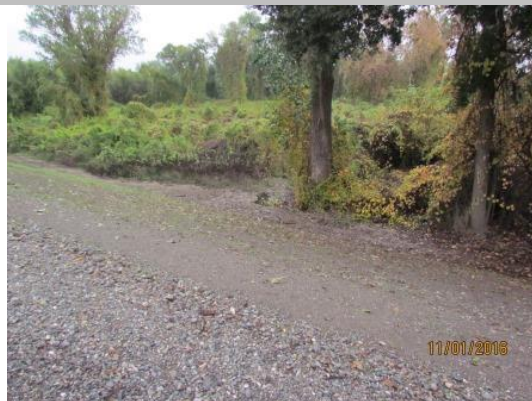
Photo 2 of 2 : FA_2016_MA0001_297_105_20161104_00163.jpg

LM Start	2.16	Rating **	M	Issue No.	105 (cont)	
LM End	2.16	Issue Type +	Ma	Location *	WS	
Category	Earthen Levee			GPS Latitude/Longitude		
				Start		End
Item	Erosion / Bank Caving			39.235107°		39.235107°
				-122.013567°		-122.013567°
DWR ID	DWR_MA0001_01_f_2016_105					
Comment Code						
E2 : Schedule repair of erosion site prior to the next inspection.						
Inspector Comment

Another close up view of the erosion site.

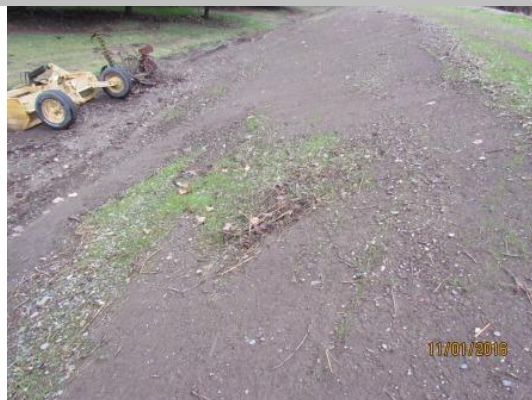
Photo 1 of 1 : FA_2016_MA0001_297_108_20161104_00166.jpg

LM Start	2.36	Rating **	M	Issue No.	108
LM End	2.36	Issue Type +	Ma	Location *	LS
Category	Earthen Levee			GPS Latitude/Longitude	
				Start	End
Item	Slope Stability			39.237628 °	39.237628 °
				-122.011967 °	-122.011967 °
DWR ID	DWR_MA0001_01_f_2016_108				
Comment Code					
S1 : Repair slope instability.					
Inspector Comment

View of the slope instability along the landside slope.

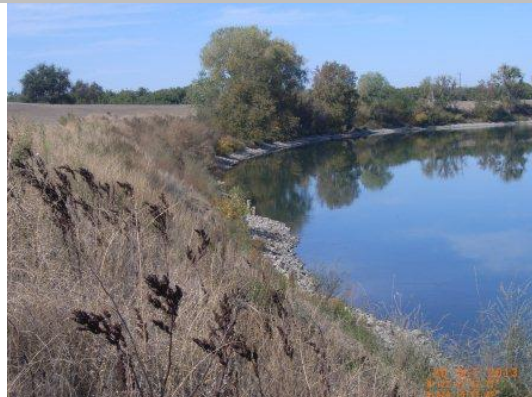
Photo 1 of 1 : FA_2016_MA0001_297_3_20160823_00002.jpg

LM Start	4.86	Rating **	M	Issue No.	3
LM End	5.26	Issue Type +	Ma	Location *	WS
Category	Supplemental			GPS Latitude/Longitude	
				Start	End
Item	2015 USACE Erosion Survey, DRAFT			39.265730 °	39.266315 °
				-122.014925 °	-122.020682 °
DWR ID	DWR_MA0001_01_s_2016_3				
Comment Code					
Inspector Comment					
2009 - Slump in the middle of the section has left a vertical section on the bank. 2010 - Old cobble site unraveling, site extended downstream. 2015: Last observed in 2013. [2015 Site ID: SAC_151-0_R]

USACE 2013 Photo #1

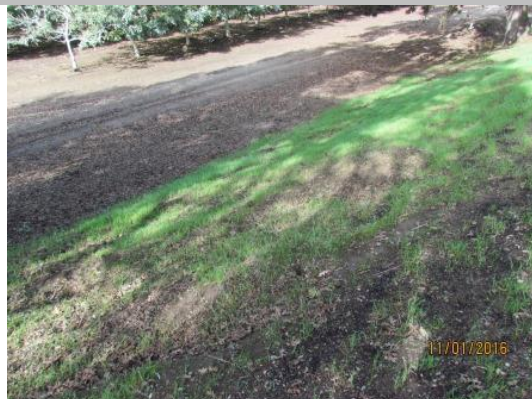
Photo 1 of 1 : FA_2016_MA0001_297_119_20161104_00174.jpg

LM Start	8.72	Rating **	M	Issue No.	119
LM End	8.72	Issue Type +	Ma	Location *	LS
Category	Earthen Levee			GPS Latitude/Longitude	
				Start	End
Item	Slope Stability			39.308272 °	39.308272 °
				-122.031215 °	-122.031215 °
DWR ID	DWR_MA0001_01_f_2016_119				
Comment Code					
S3 : Repair the levee slope damaged by vehicle traffic and prevent access where possible.					
Inspector Comment

View of the slope instability caused by vehicles along the landside slope.

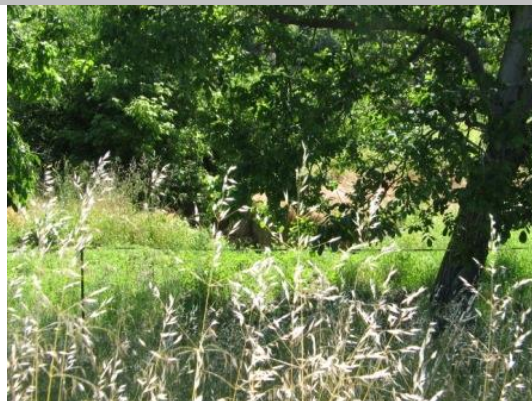
Photo 1 of 1 : FA_2016_MA0001_297_18_20160823_00009.jpg

LM Start	10.13	Rating **	M	Issue No.	18
LM End	10.13	Issue Type +	Ma	Location *	WS
Category	Earthen Levee			GPS Latitude/Longitude	
				Start	End
Item	Erosion / Bank Caving			39.328697 °	39.328697 °
				-122.029262 °	-122.029262 °
DWR ID	DWR_MA0001_01_s_2012_18				
Comment Code					
E1 : Note and monitor erosion site.					
Inspector Comment					
Monitor the erosion site.

View of the erosion along the waterside of the levee.

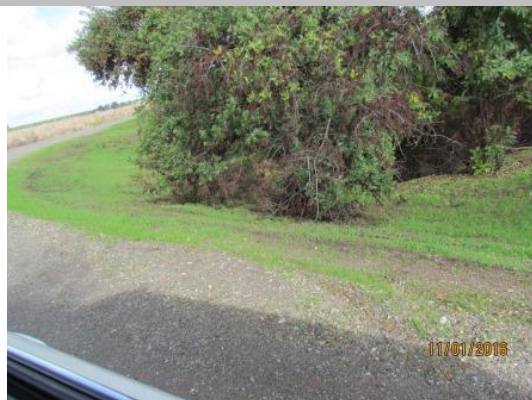
Photo 1 of 1 : FA_2016_MA0001_297_120_20161107_00175.jpg

LM Start	11.00	Rating **	M	Issue No.	120
LM End	11.00	Issue Type +	Ma	Location *	WS
Category	Earthen Levee			GPS Latitude/Longitude	
				Start	End
Item	Trim / Thin Trees			39.340728 °	39.340728 °
				-122.032897 °	-122.032897 °
DWR ID	DWR_MA0001_01_f_2016_120				
Comment Code					
T1 : Trim trees to at least five feet above ground level.					
Inspector Comment

View of the tree with overhanging branches.

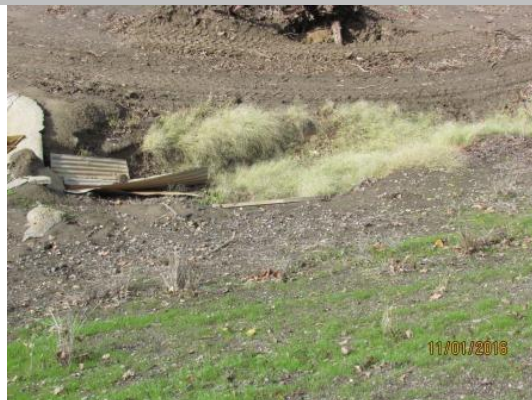
Photo 1 of 1 : FA_2016_MA0001_297_121_20161107_00176.jpg

LM Start	11.46	Rating **	M	Issue No.	121
LM End	11.46	Issue Type +	Ma	Location *	LS
Category	Earthen Levee			GPS Latitude/Longitude	
				Start	End
Item	Slope Stability			39.347168°	39.347168°
				-122.031533°	-122.031533°
DWR ID	DWR_MA0001_01_f_2016_121				
Comment Code					
S1 : Repair slope instability.					
Inspector Comment					
Backfill and compact.

View of the low spot along the levee toe created by adjacent ditch overflow.

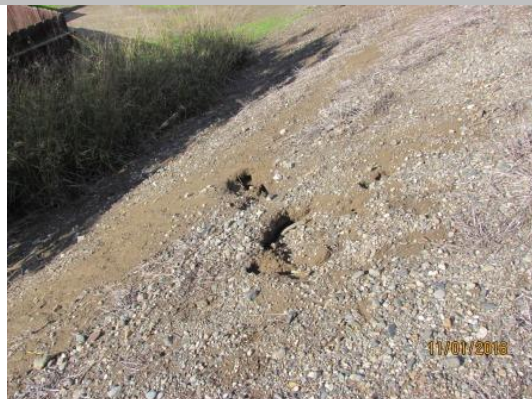
Photo 1 of 1 : FA_2016_MA0001_297_132_20161107_00188.jpg

LM Start	15.99	Rating **	M	Issue No.	132
LM End	15.99	Issue Type +	Ma	Location *	LS
Category	Earthen Levee			GPS Latitude/Longitude	
				Start	End
Item	Animal Control			39.402605 °	39.402605 °
				-122.009348 °	-122.009348 °
DWR ID	DWR_MA0001_01_f_2016_132				
Comment Code					
A3 : No rodents visible, but rodent burrows visible; need to backfill and compact or grout burrows.					
Inspector Comment

View of the rodent holes along the landside slope.

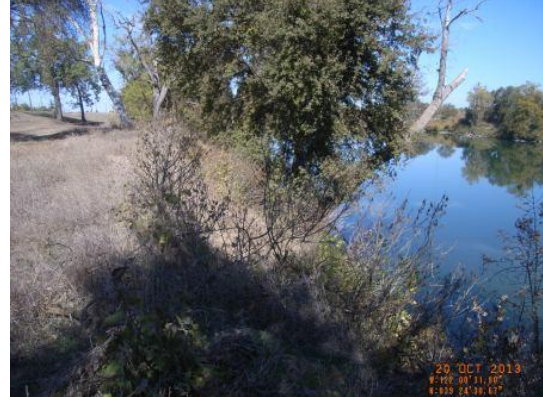
Photo 1 of 2 : FA_2016_MA0001_297_9_20160823_00006.jpg

LM Start	16.35	Rating **	M	Issue No.	9
LM End	16.58	Issue Type +	Ma	Location *	WS
Category	Supplemental			GPS Latitude/Longitude	
				Start	End
Item	2015 USACE Erosion Survey, DRAFT			39.407837 °	39.411111 °
				-122.008763 °	-122.009238 °
DWR ID	DWR_MA0001_01_s_2016_9				
Comment Code					
Inspector Comment					
Erosion site added in 1997 and removed in 2005. 2009 - Site added back in, hard toe with slow moving erosion. Potential geotechnical failure. 2011 - Site extended downstream. 2015: Last observed in 2013. [2015 Site ID: SAC_164-3_R]

USACE 2013 Photo #1

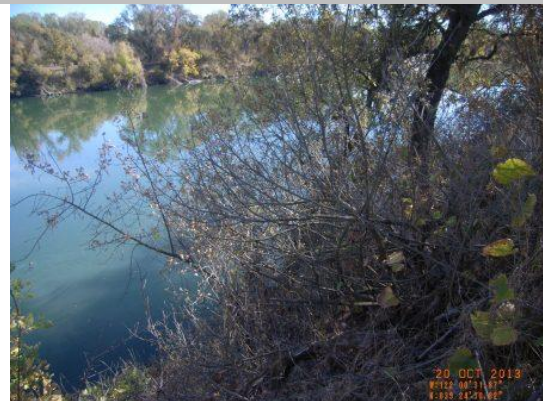
Photo 2 of 2 : FA_2016_MA0001_297_9_20160823_00007.jpg

USACE 2013 Photo #2
